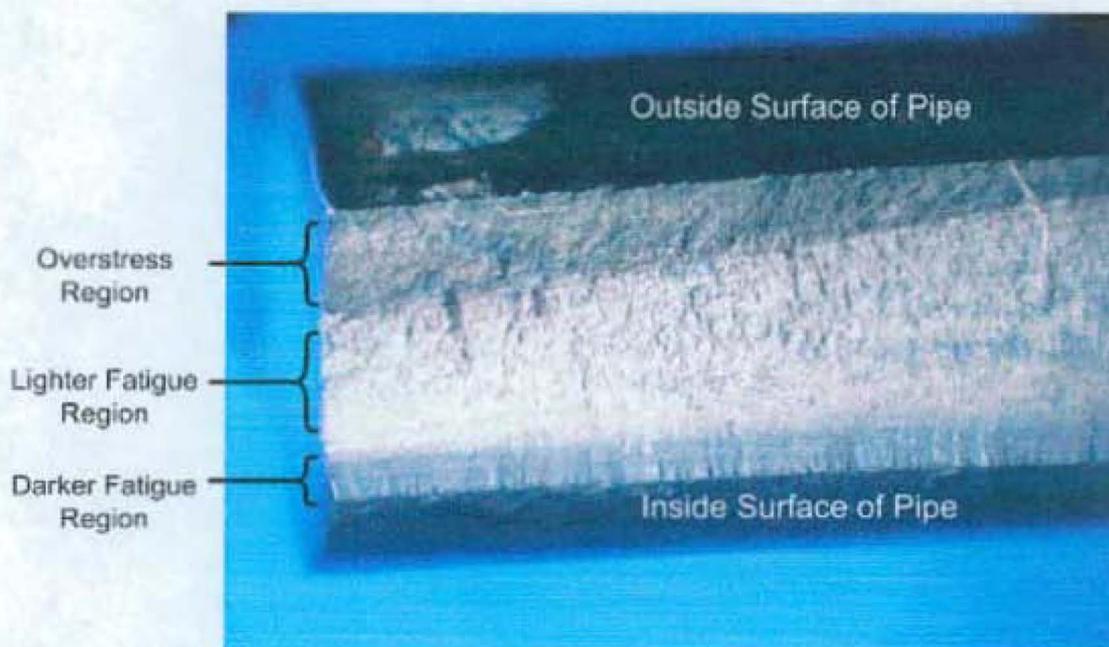
Figure 7. Face of fracture in accident pipe.
